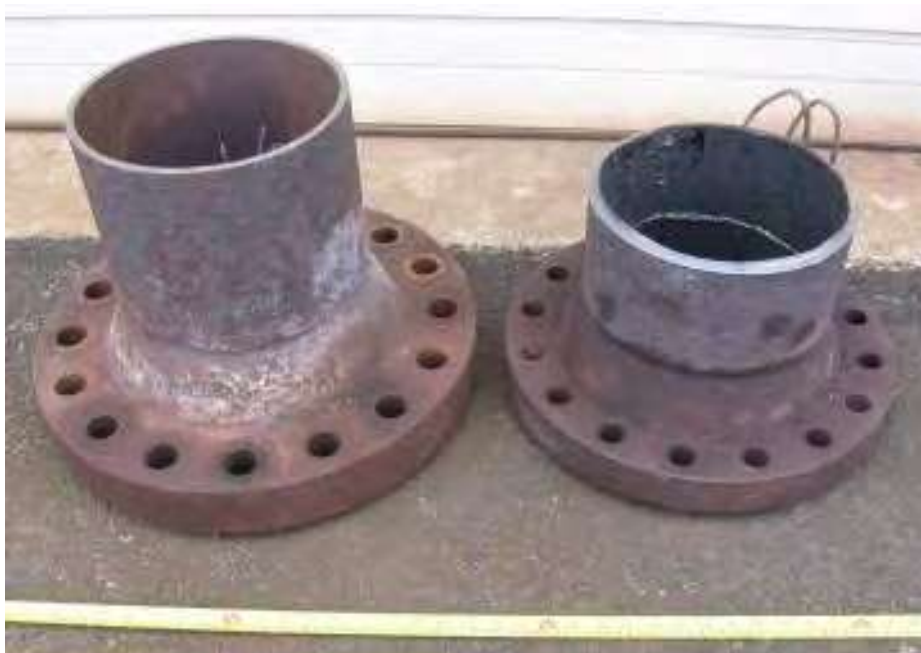
**Figure 3-36-2—A pair of 10-in. C- $\frac{1}{2}$ Mo flanged pipe sections (SA335-P1 and SA234-WP1) from a hot bypass line in a catalytic reformer that was designed to remain closed but operated partially or fully open for unknown lengths of time. They were in service for ~34 years at temperatures up to 960 °F (515 °C) with a hydrogen partial pressure of 198 psig (1.4 MPa).**

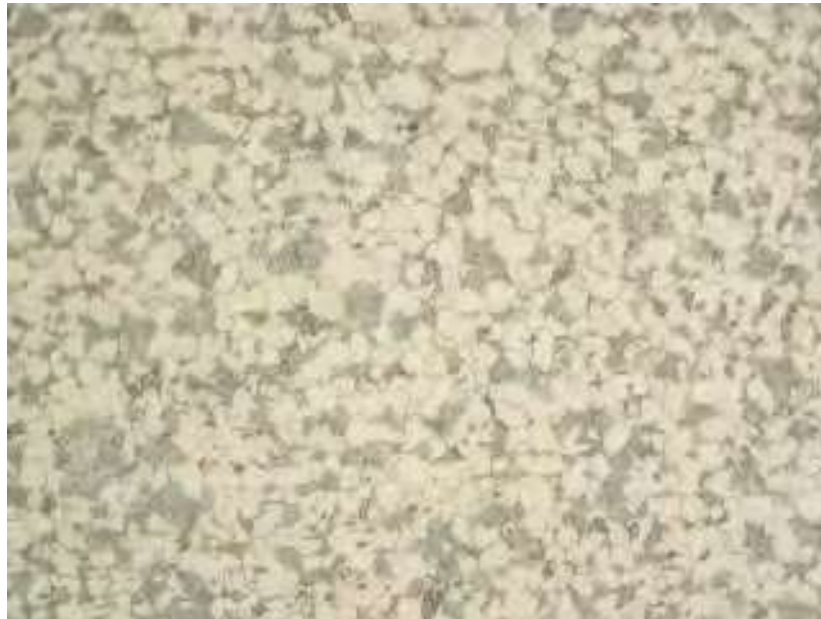
**Figure 3-36-3—A photomicrograph of the OD surface of a pipe section from Figure 3-35-2 exhibits a normal ferritic-pearlitic microstructure. Magnification 200X.**

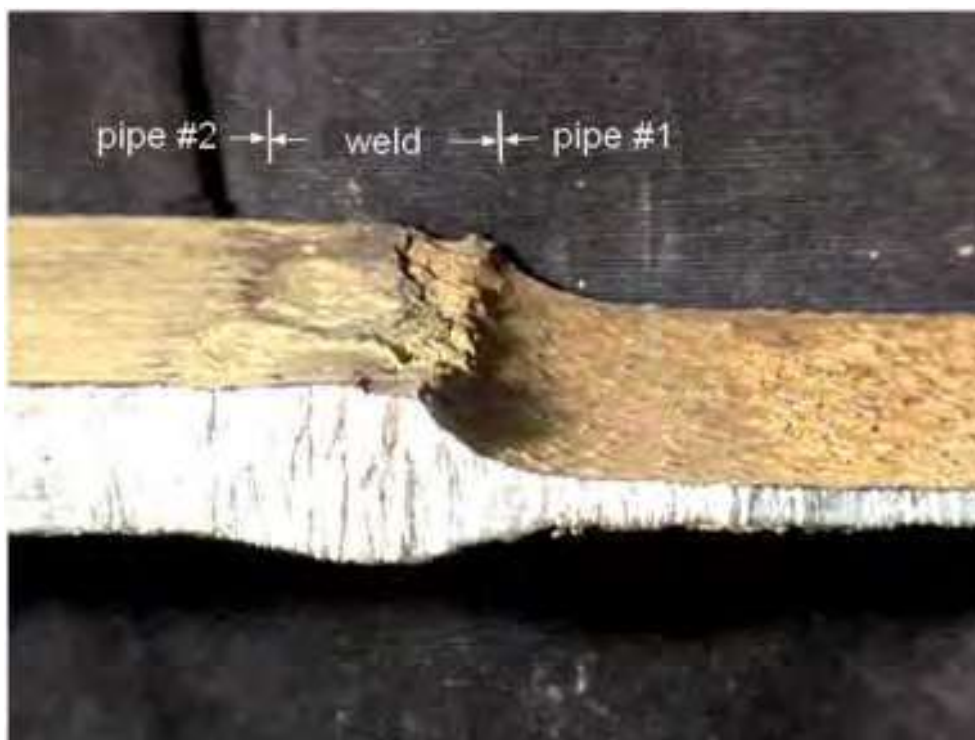
Figure 3-38-3—Cross section of a carbon steel pipe showing preferential corrosion of the pipe with high RE content on the right, as compared to the low-RE pipe section to the left of the weld. (Reference 3)

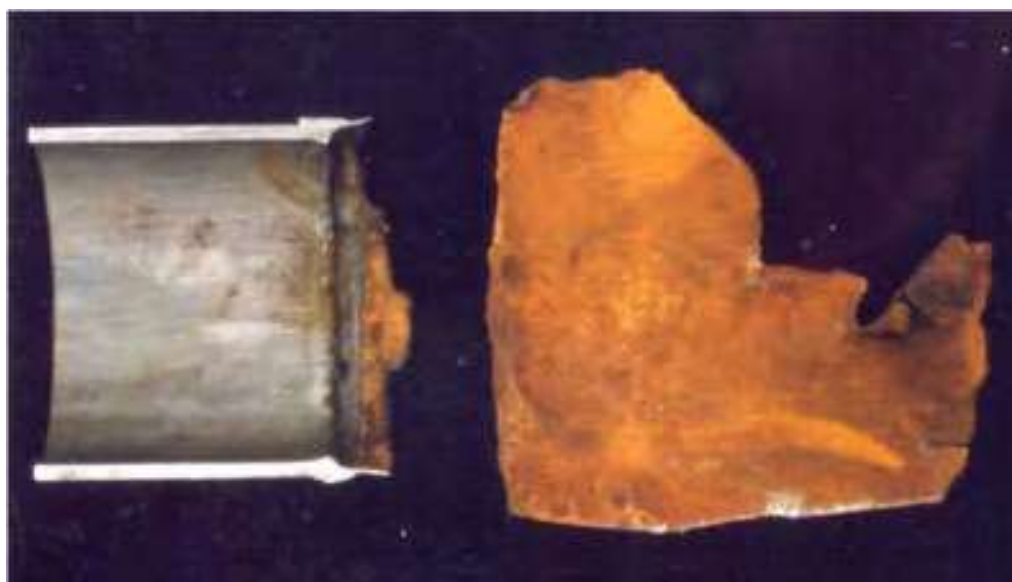
**Figure 3-38-4—Ruptured NPS 3 Sch. 80 [0.216 in. (5.5 mm) wall thickness] depropanizer feed line operating < 120 °F (50 °C). RE content is as follows.**  
Both base metals: %C > 0.18 wt %; %Cu + %Ni < 0.15.  
Weld metal: %Cu + %Ni + %Cr < 0.15.

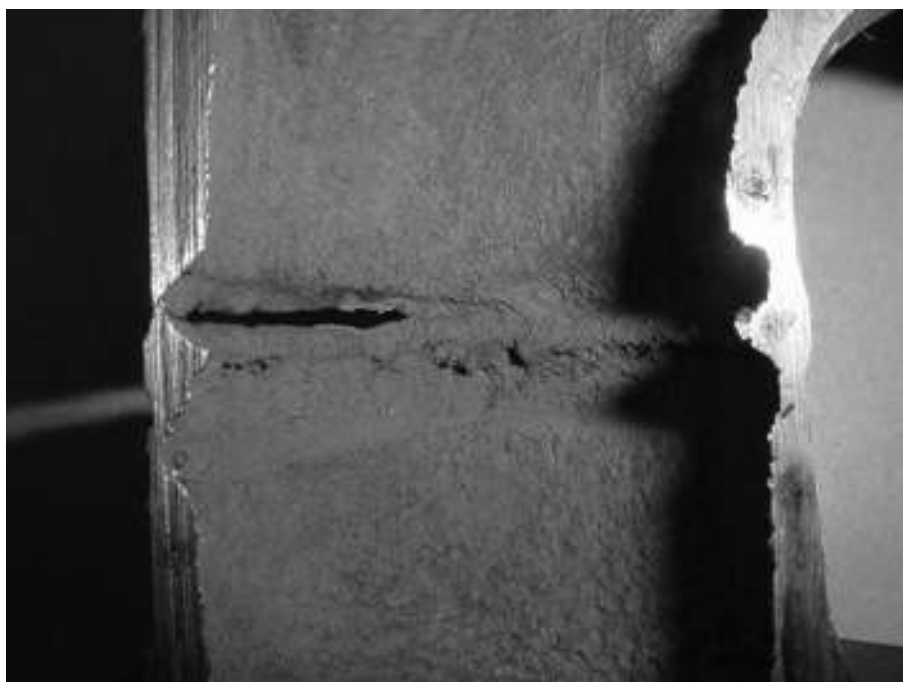
**Figure 3-38-6—Accelerated corrosion in the HAZ of a carbon steel weldment. RE content is as follows. (Reference 8)**  
Both base metals: %C > 0.18 wt %; %Cu + %Ni < 0.15.  
Weld metal: %Cu + %Ni + %Cr < 0.15.

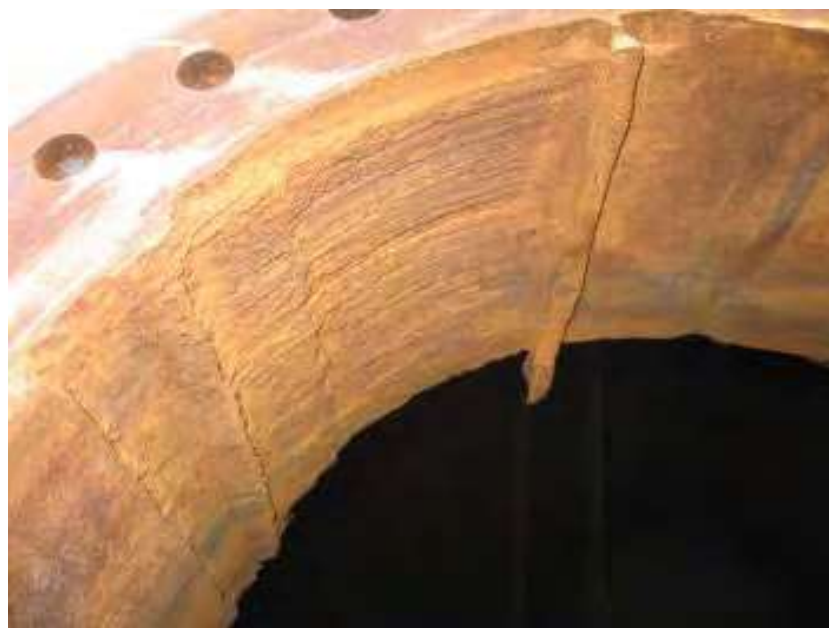
**Figure 3-38-7—HF corrosion at a manway in HF acid storage service.**

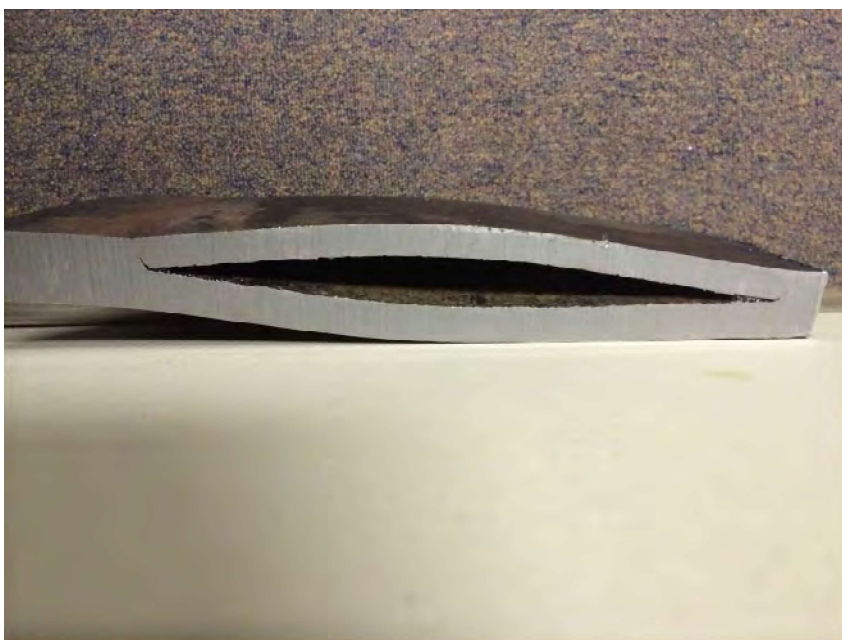
**Figure 3-38-8—Internal blister caused by HF corrosion near the top of a 1.2-in.-thick carbon steel tower in an HF alkylation unit. The maximum measured dimensions of the blister were 2 ft high and 20 ft long (circumferentially). The hanging weight of an adjacent tray, which was also badly corroding, may have contributed to the location and size of the blister.**

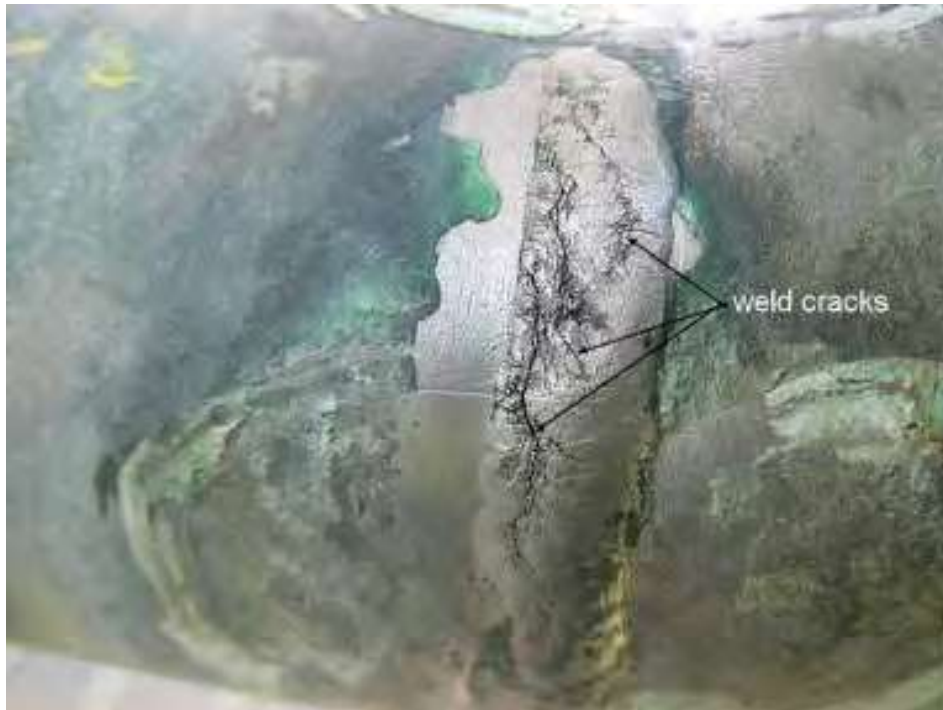
**Figure 3-39-1—HF SCC of an Alloy 400 vent line in an acid dump system. (Reference 7)**

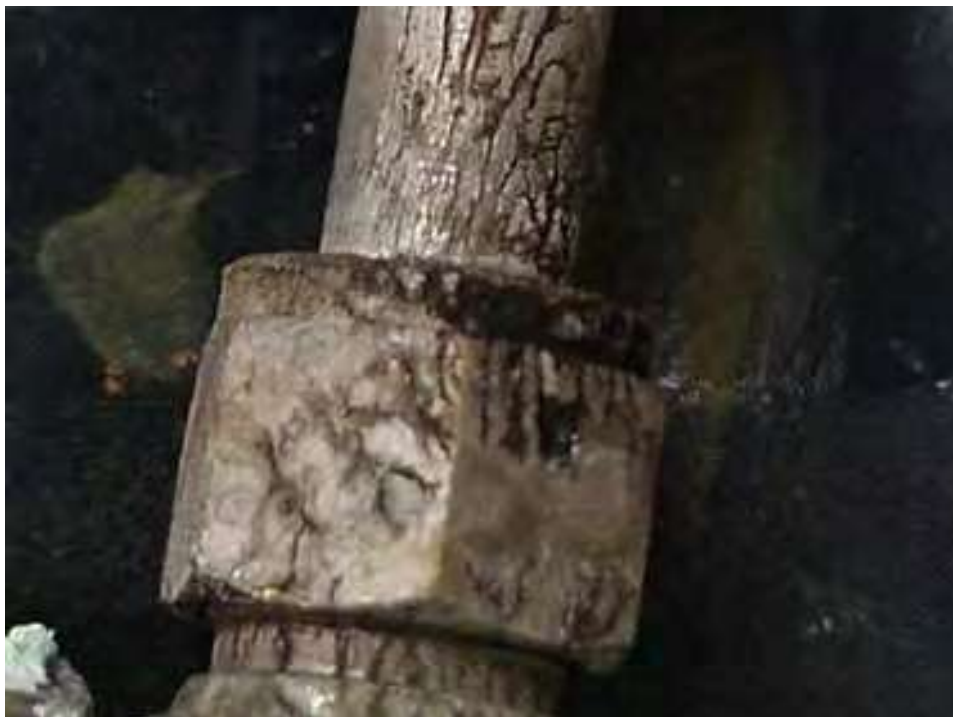
**Figure 3-39-2—HF SCC of Alloy 400 instrument tubing. (Reference 7)**

- a) HF alkylation units employing nickel alloys for equipment pressure boundaries, internals, instruments, valve components (especially stems), and pump components. ([Figure 3-39-1](#) and [Figure 3-39-2](#))

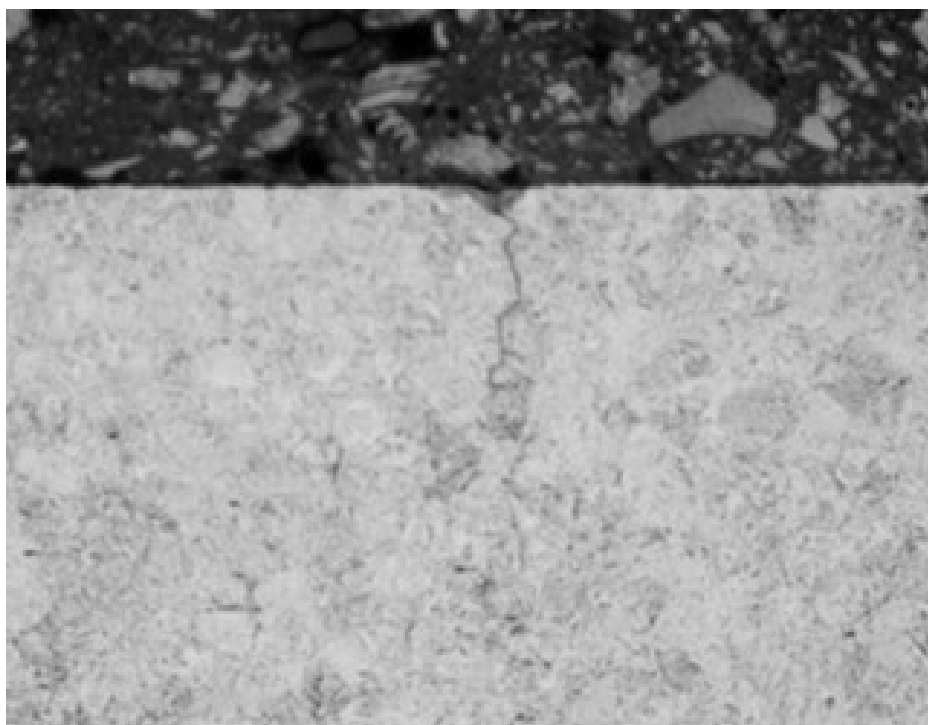
**Figure 3-40-1—(a) Cracking due to HE of a high-strength steel tube.  
(b) Intergranular crack emanating from surface in the tube.**

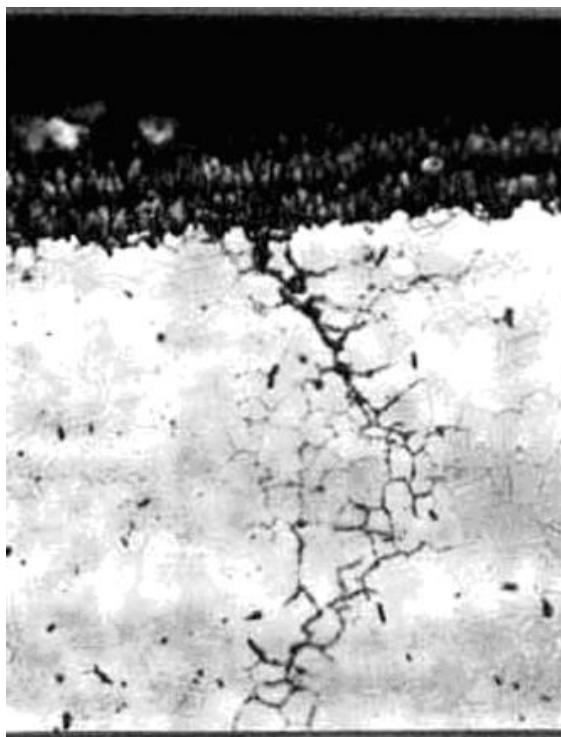
**Figure 3-42-2—Photomicrograph of a section of the elbow in Figure 3-40-1, illustrating the intergranular nature of zinc-filled cracks in stainless steel.**

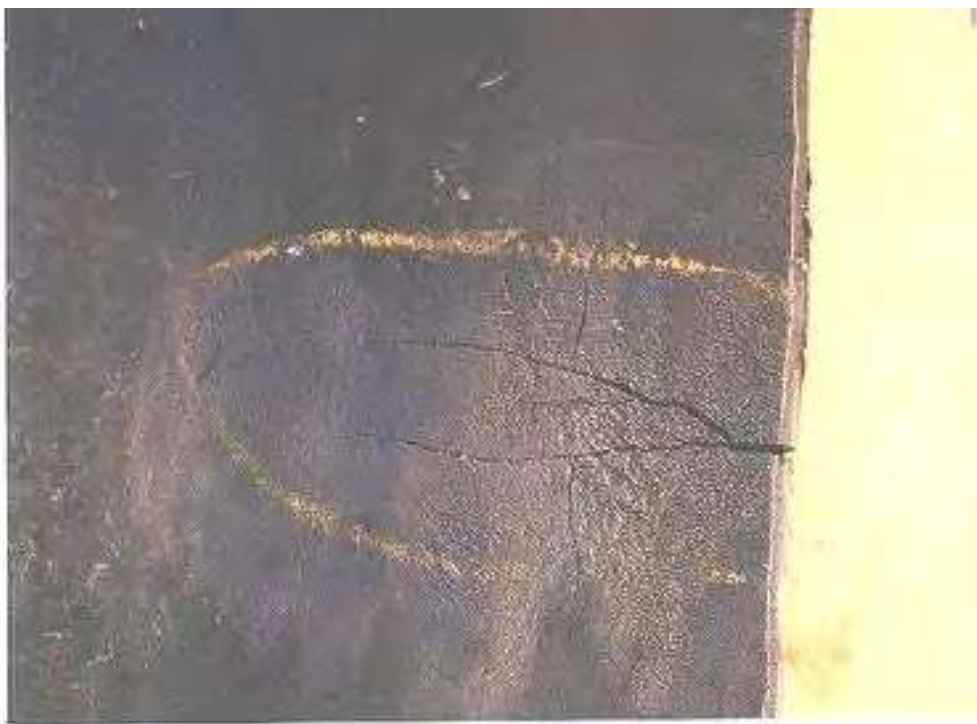
**Figure 3-42-3—LME of Monel caused by mercury in an FCC gas plant overhead drum.**

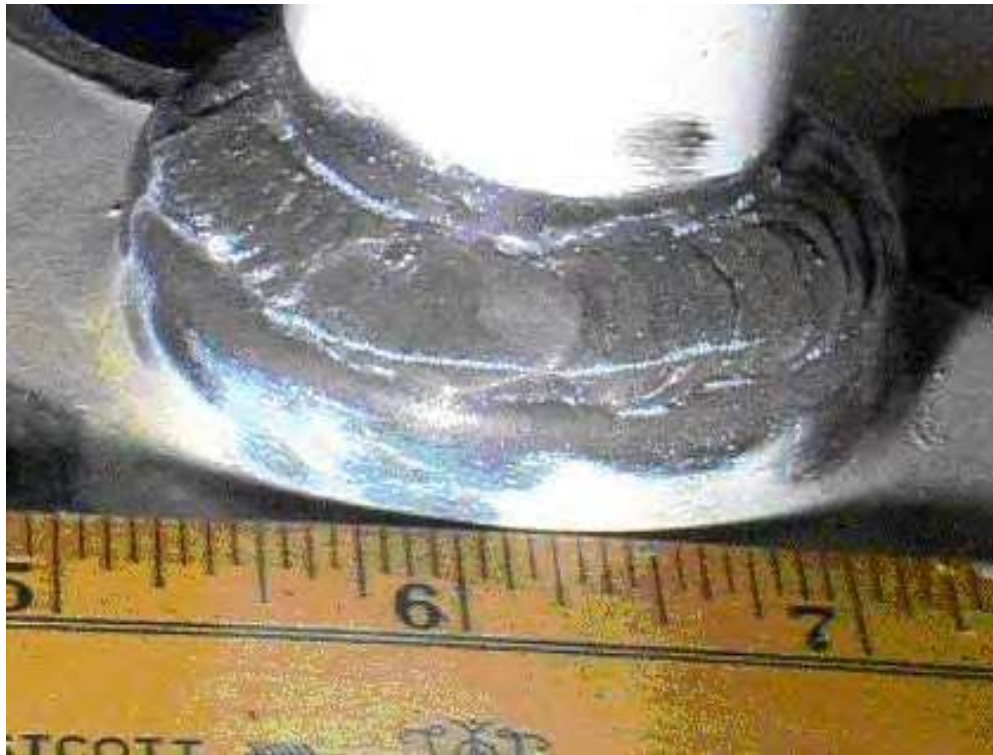
**Figure 3-43-1—Vibration induced fatigue of a 1-in. socket weld flange in a thermal relief system shortly after start-up.**

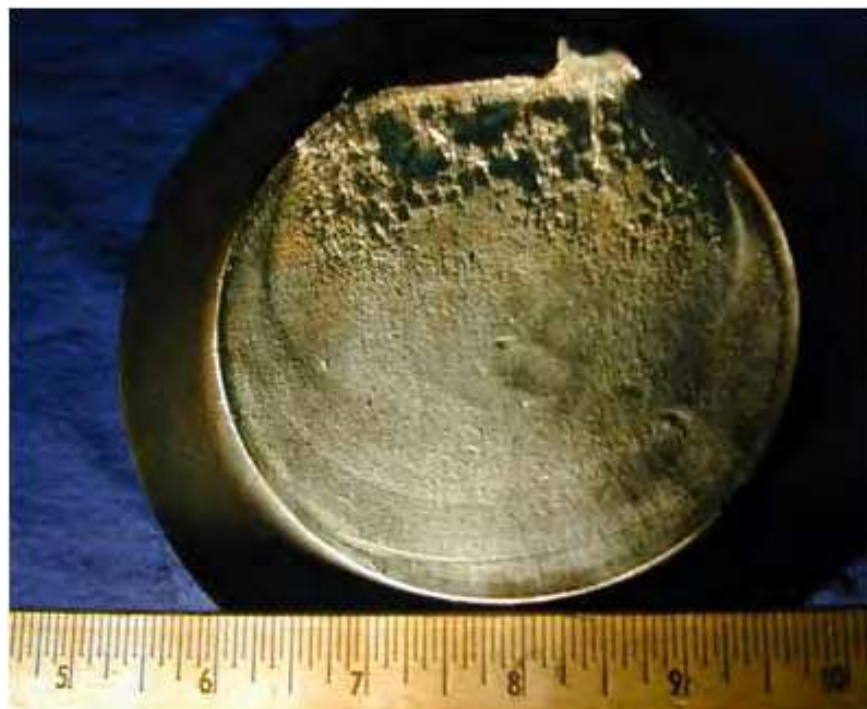
Figure 3-43-6—Compressor rod fracture surface showing “beach marks.”

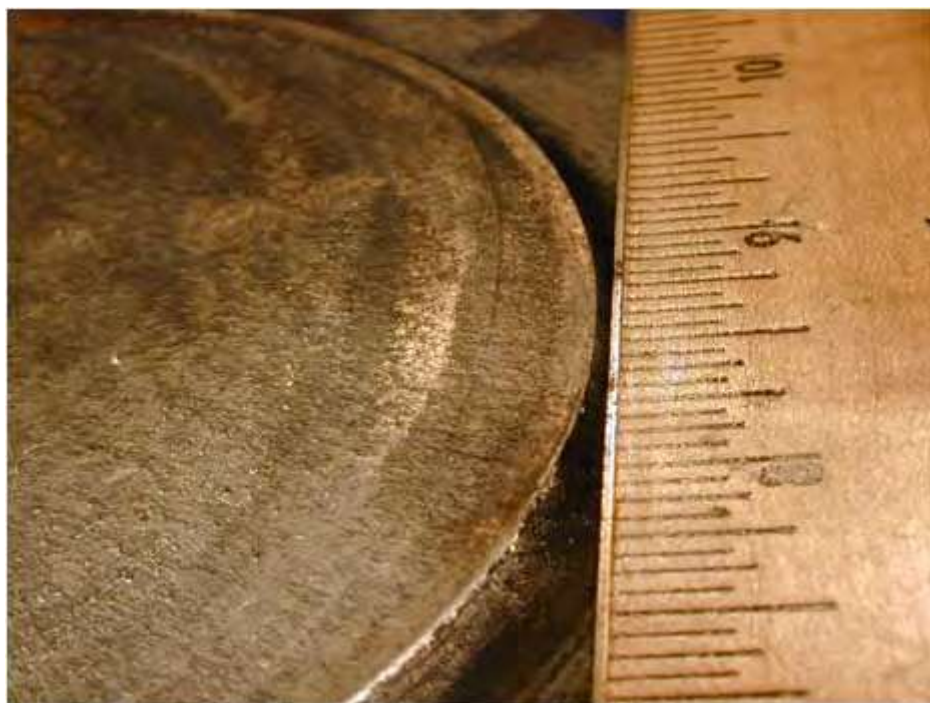
Figure 3-43-7—Higher-magnification view of Figure 3-41-6 above showing “beach marks.”

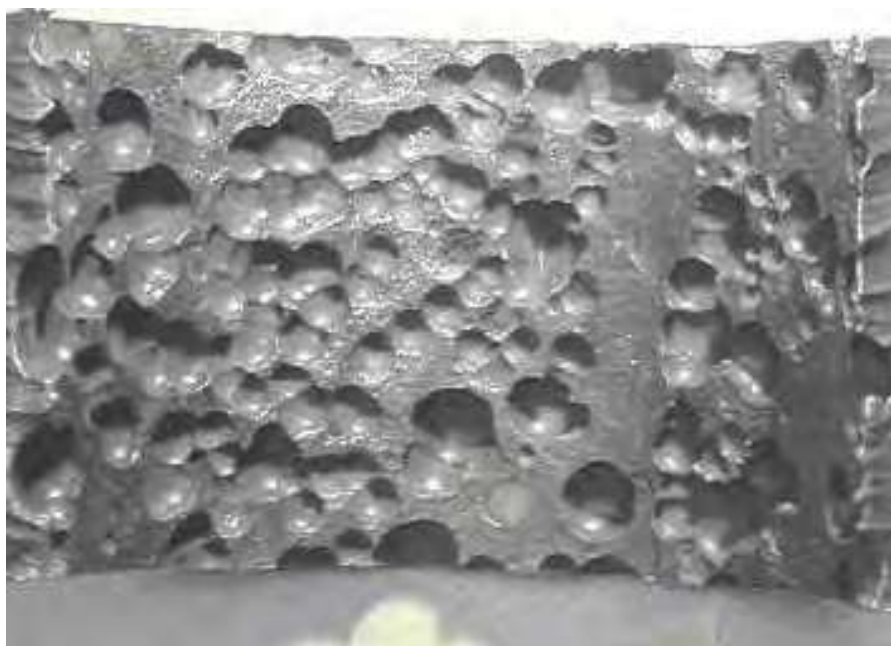
Figure 3-44-1—Metal dusting of a 304H stainless steel pipe.

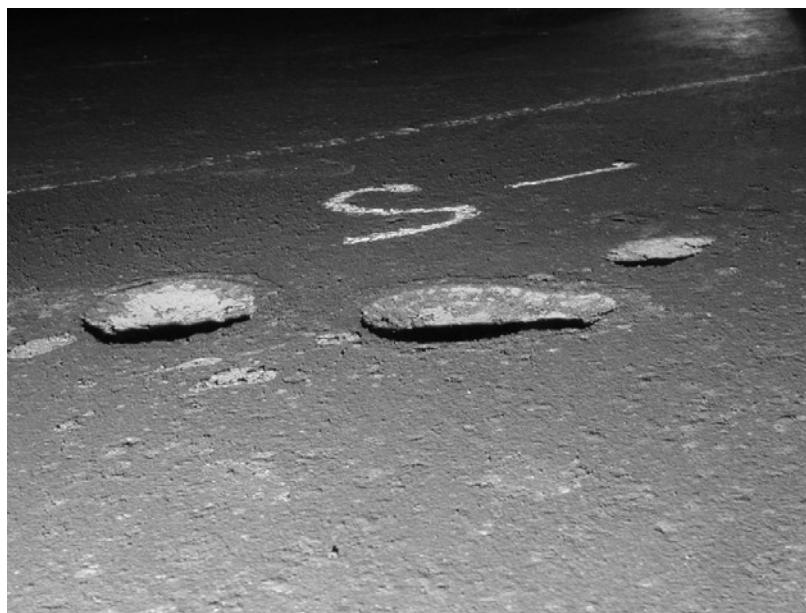
**Figure 3-45-1—MIC on a diesel tank bottom.**

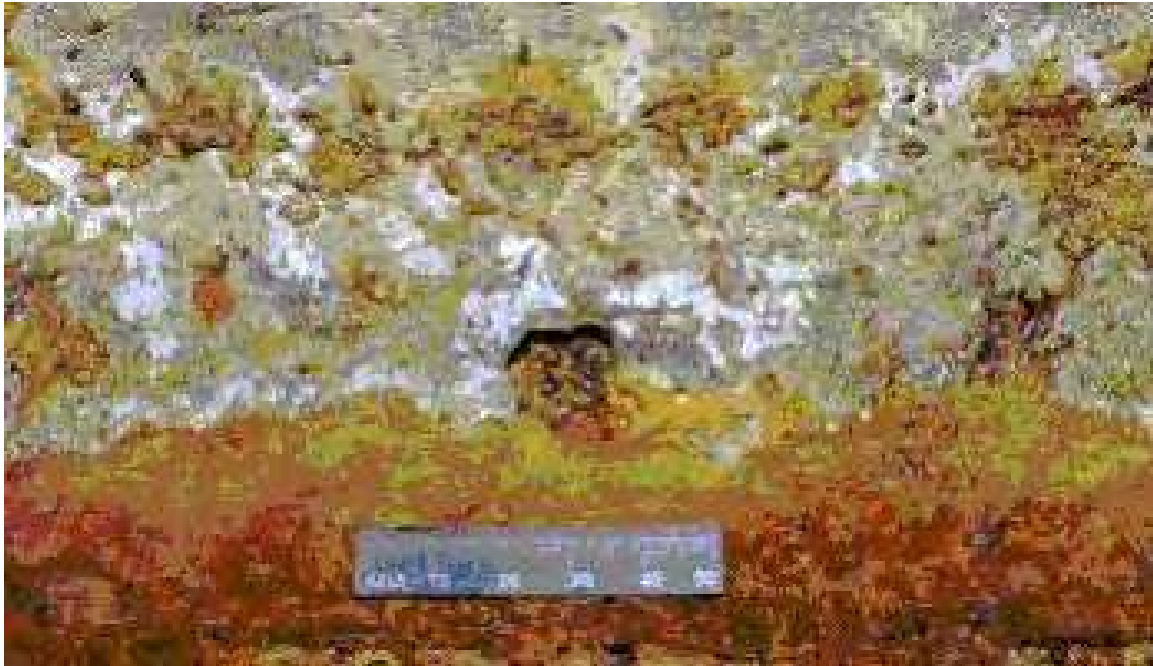
**Figure 3-45-4—Oil line with MIC damage beneath tubercles.**

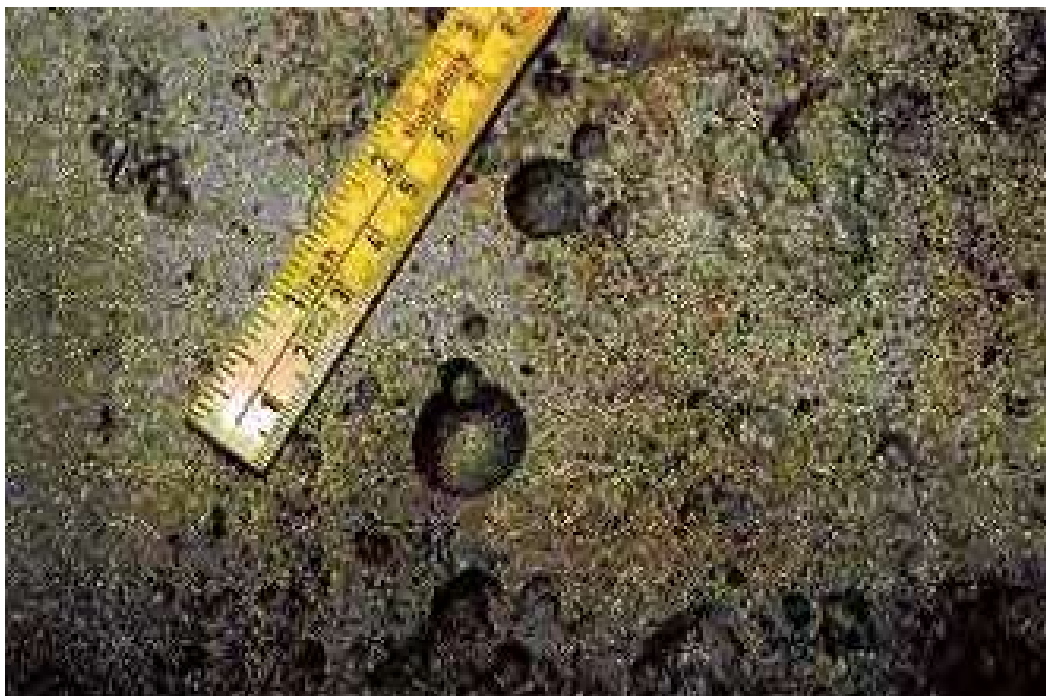
**Figure 3-45-5—Same oil line as Figure 3-43-4. Hemispherical pitting typical of MIC can be seen after grit blasting to remove the scale.**

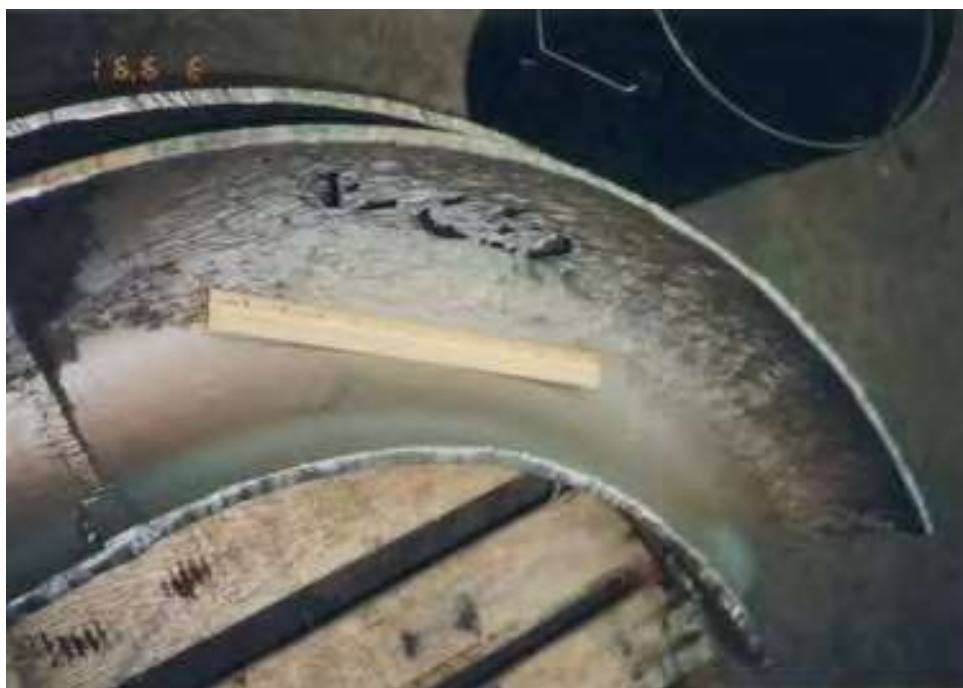
**Figure 3-46-1—Erosion-corrosion damage due to NAC in a 10-in. 5Cr- $\frac{1}{2}$ Mo elbow in the outlet of a vacuum heater in a vacuum distillation unit.**

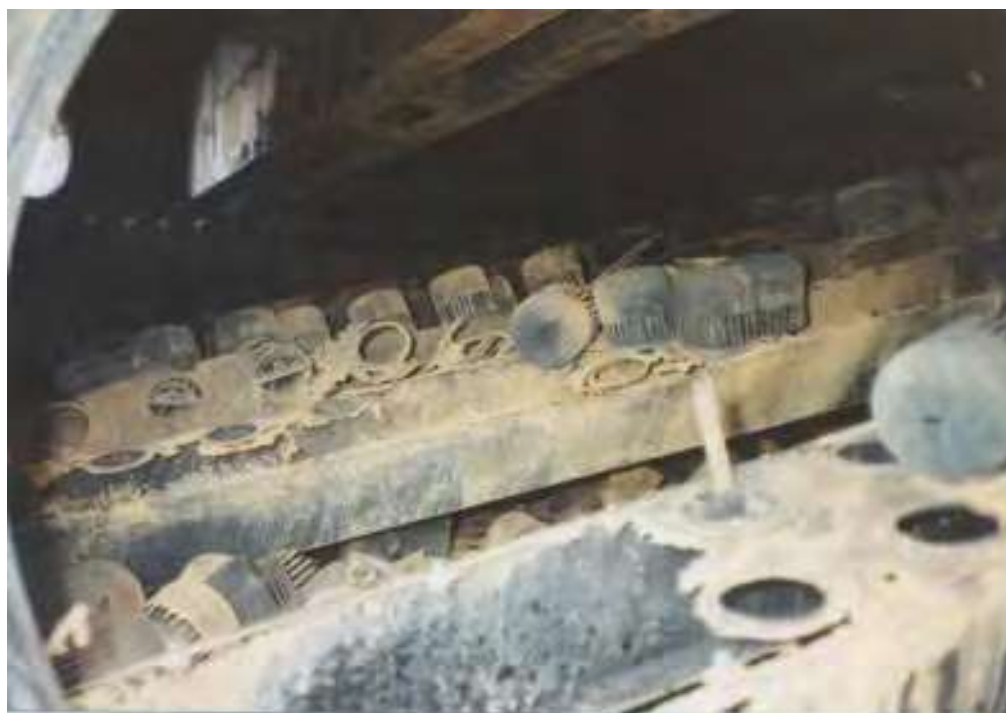
**Figure 3-46-2—Severe NAC of 410 SS trays and bubble caps in the HVGO section of the vacuum tower fed by the vacuum heater referred to in Figure 3-44-1.**

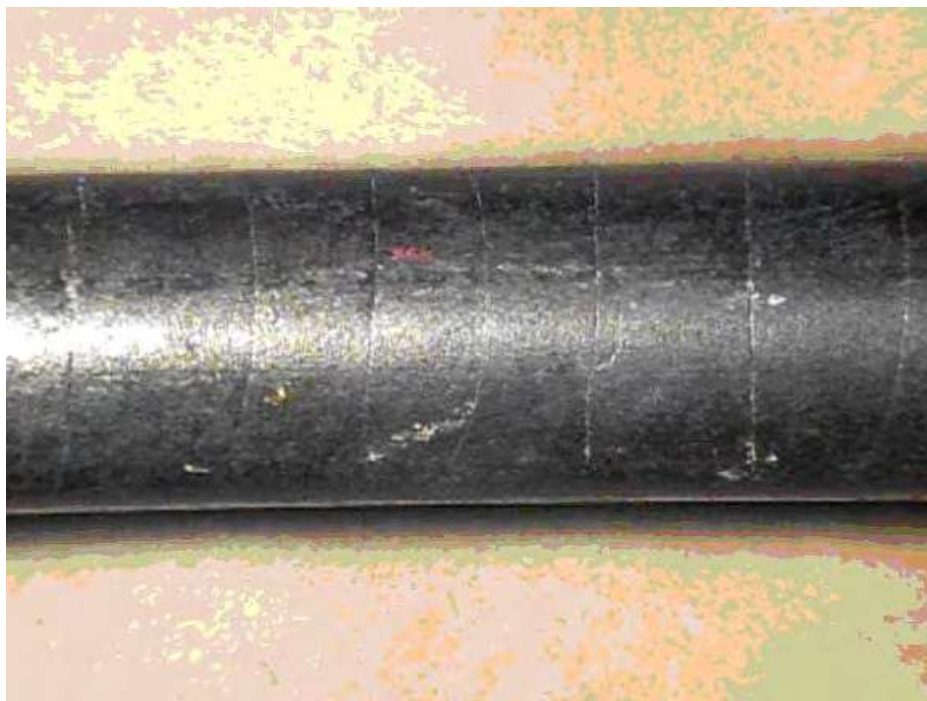
**Figure 3-47-1—A nitrided 5Cr- $\frac{1}{2}$ Mo thermowell tube from an ammonia synthesis plant with surface cracking.**

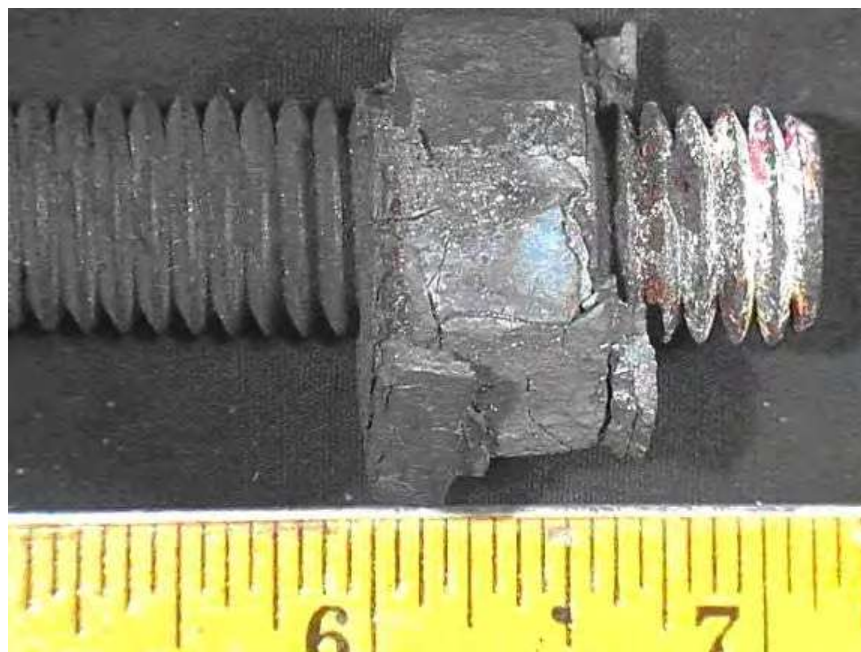
Figure 3-48-2—Oxidation of a carbon steel nut on a stainless steel stud at 1300 °F (705 °C).

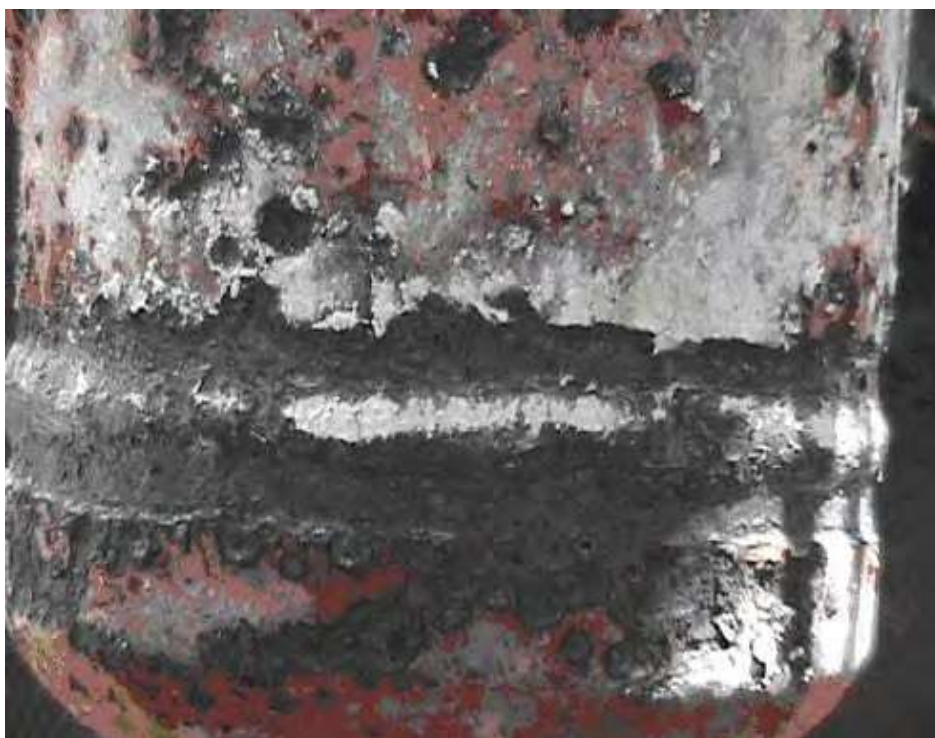
Figure 3-48-4—Oxidation of the OD of a carbon steel furnace transfer line.

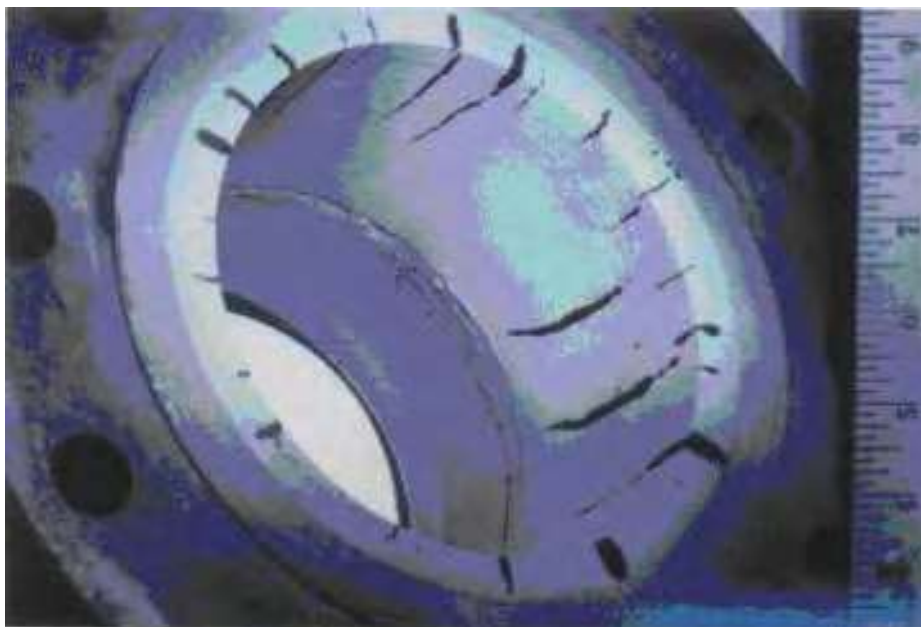
**Figure 3-52-3—PT inspection of a Type 304 stainless steel catalyst withdrawal line piping and weld neck flange.**

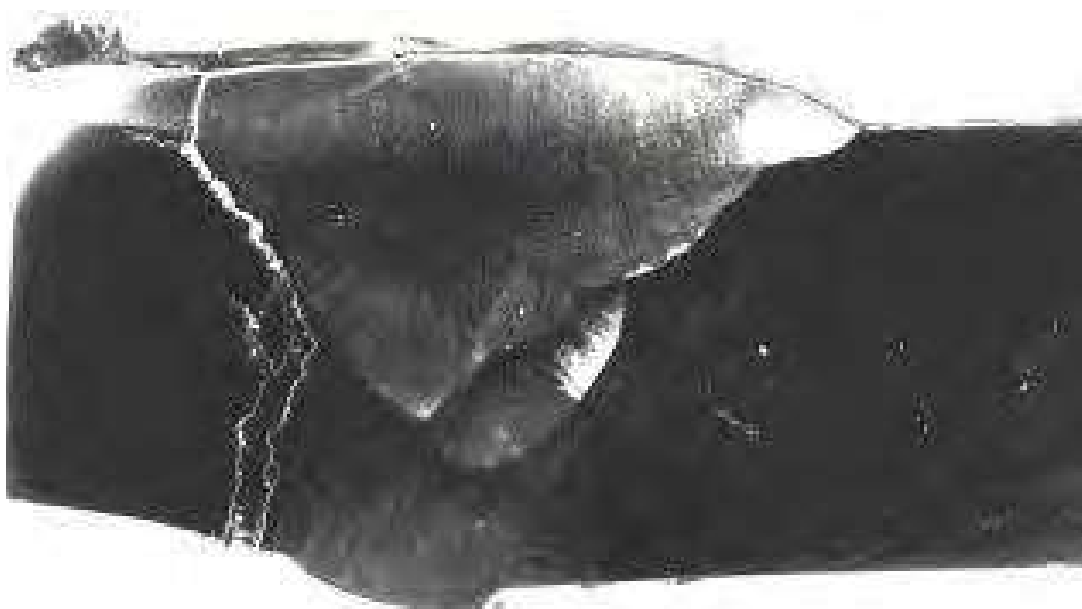
**Figure 3-52-4—Cross section of the catalyst withdrawal line attached to the flange in Figure 3-50-3 showing cracking in the weld HAZ. Magnification 3X.**

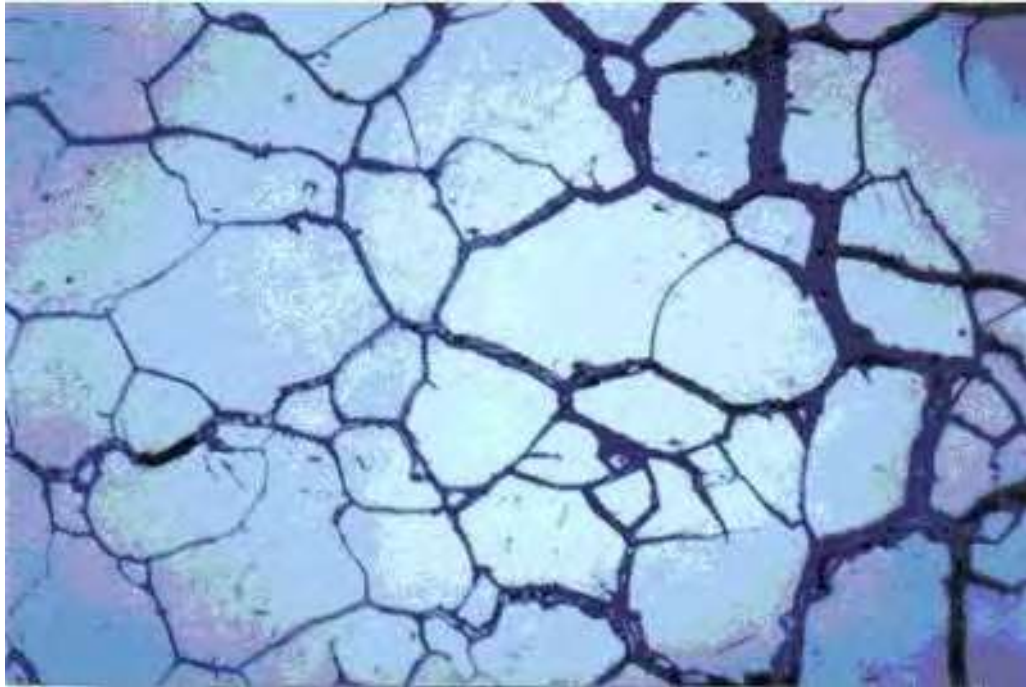
**Figure 3-52-5—Higher-magnification view showing intergranular cracking. Magnification 200X.**

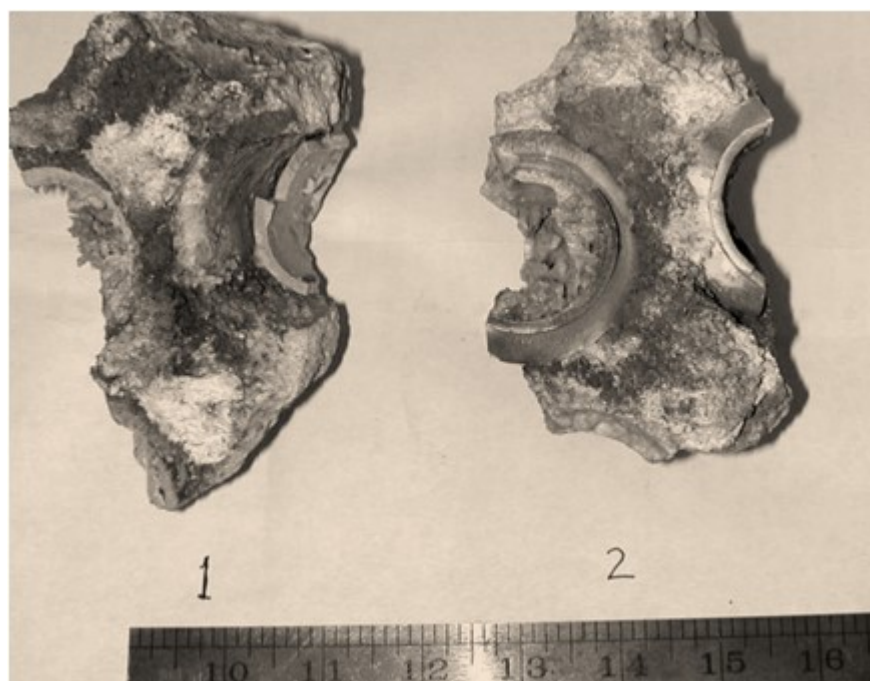
Figure 3-53-1—Damaged refractory and ferrules.

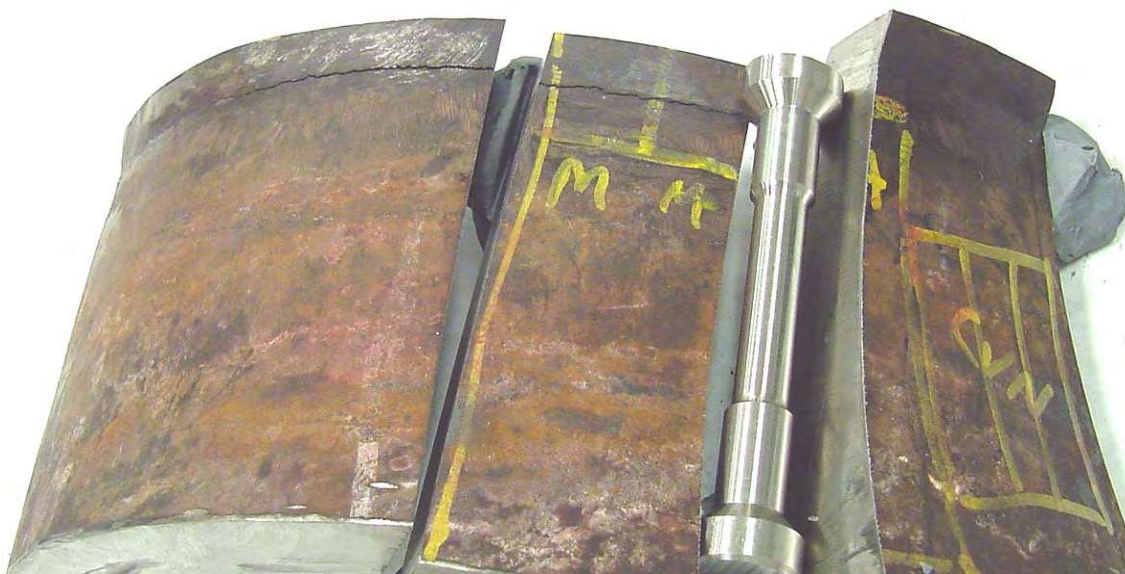
**Figure 3-54-1—Samples removed from a cracked 12-in. NPS Type 321 SS elbow in a hot recycle H<sub>2</sub> line that operated at 985 °F (530 °C) in a hydrocracker.**

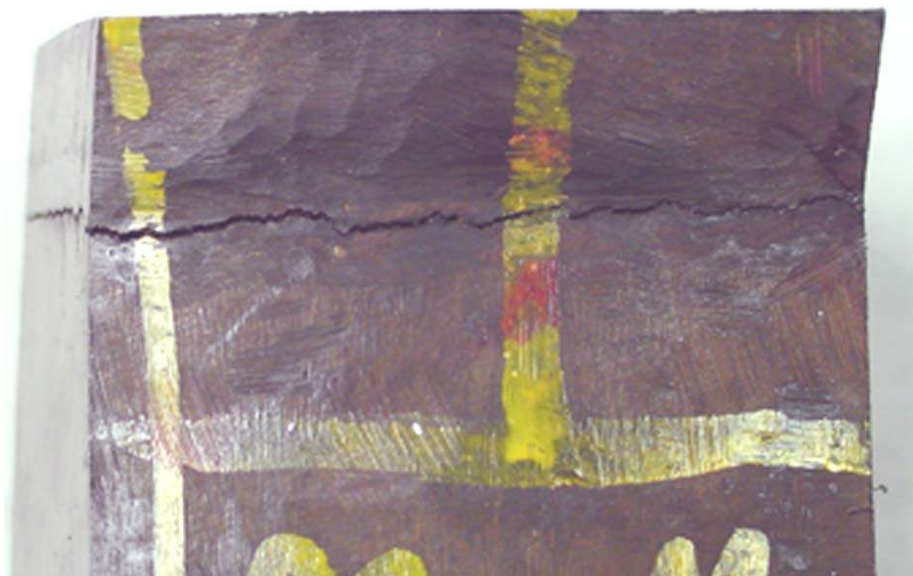
**Figure 3-54-2—Crack at weld from Type 321 SS elbow shown in Figure 3-52-1.**

- a) SRC is intergranular and can be surface breaking or embedded depending on the state of stress and geometry. It is most frequently observed in coarse-grained sections of a weld HAZ; however, it can also occur in weld deposits. ([Figure 3-54-1](#) to [Figure 3-54-4](#))
- b) In many cases, cracks initiate at some type of stress concentration. Once initiated, SRC cracks can enable further propagation by fatigue cracking.

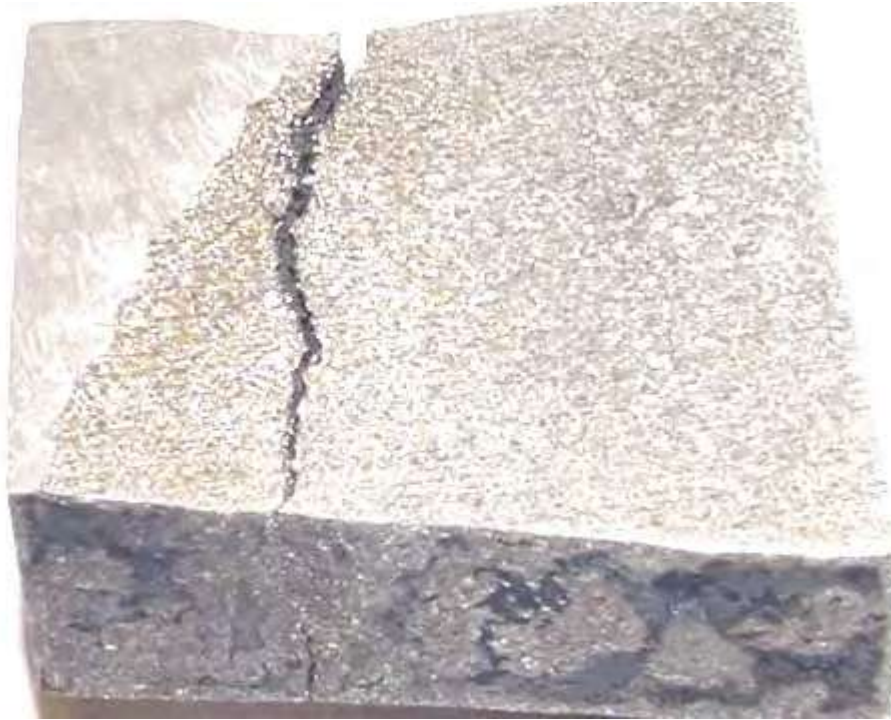
**Figure 3-54-3—Cross section through the weldment showing the crack in Figure 3-52-2.**

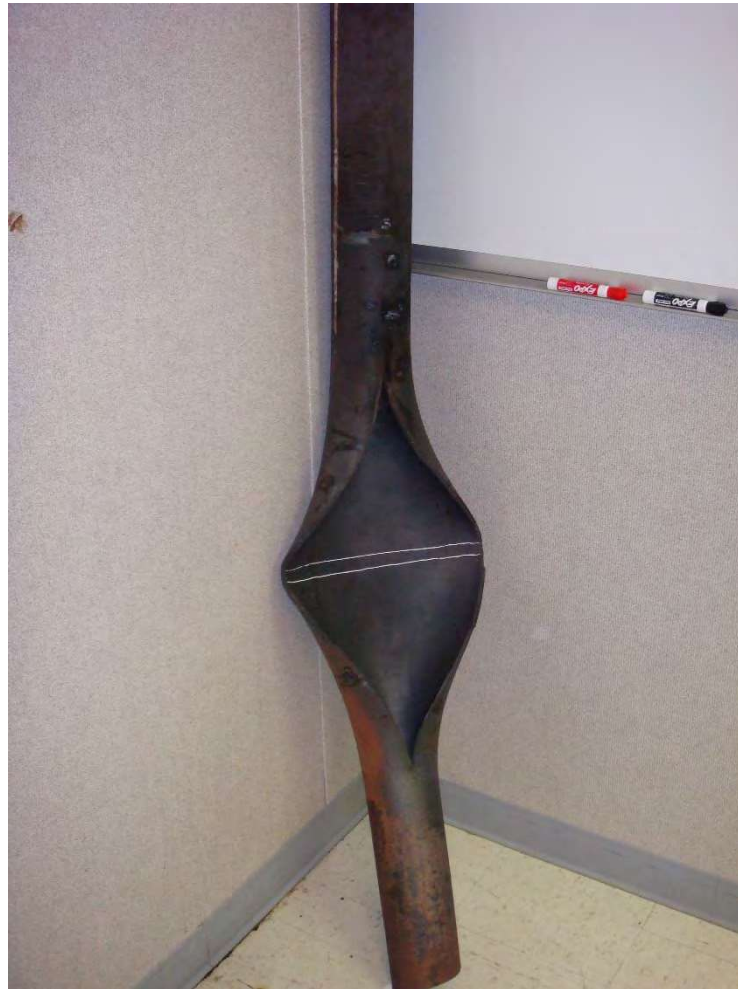
**Figure 3-55-1—Short-term overheating failure of a vertical, 4.5-in. OD, schedule 160 2¼Cr-1Mo (SA335-P22) hydrocracker radiant tube that was 21 years old. Failure resulted from process-side starvation with the burners running.**

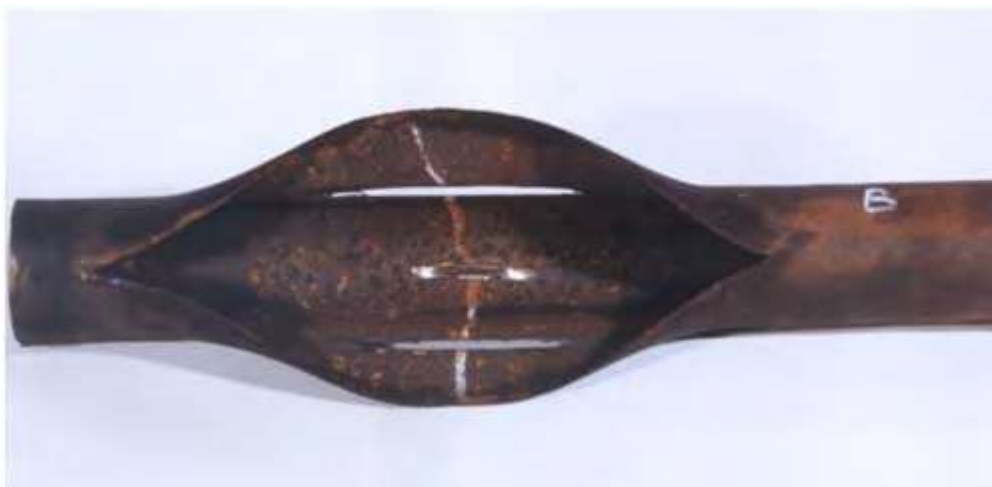
**Figure 3-55-2—Tube bulged and ruptured due to short-term overheating at a temperature well over 1380 °F (750 °C).**

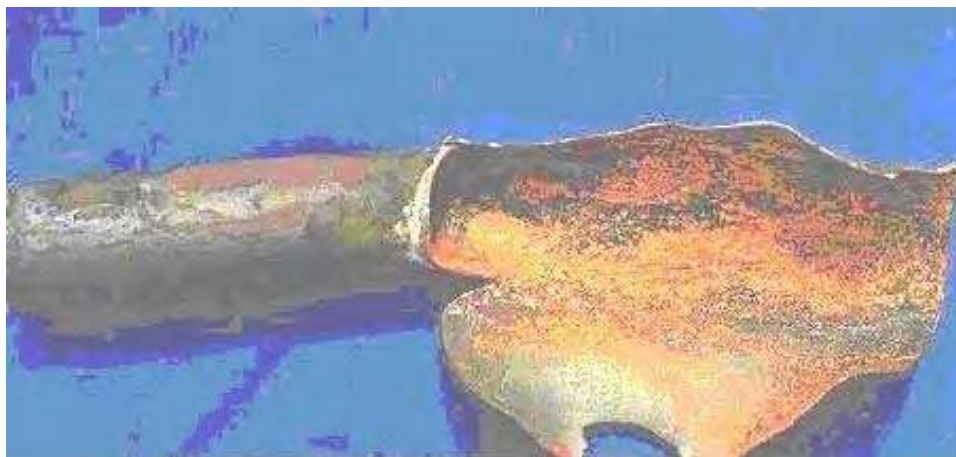
**Figure 3-55-3—1Cr- $\frac{1}{2}$ Mo boiler superheater tube in 700 psig steam service that failed due to overheating.**

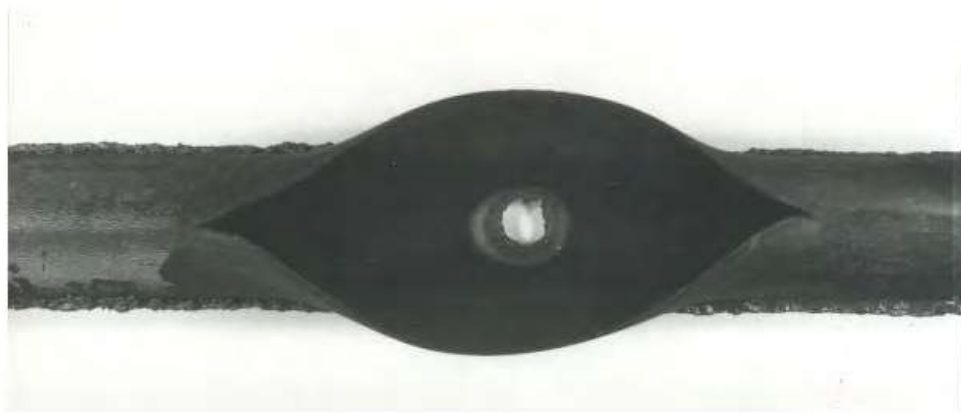
**Figure 3-55-5—Short-term, high-temperature boiler tube failures from DNB are wide-open bursts with the failure lips drawn to a near knife edge. They are ductile ruptures. Magnification 25X.**
