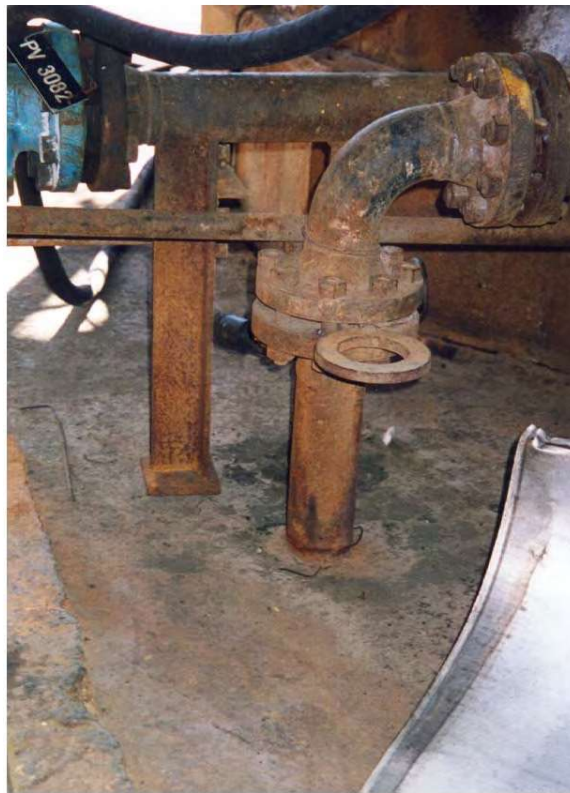
**Figure 3-57-1—Corrosion of carbon steel pipe at the soil/air interface where the pipe emerges from underground.**

- d) Soils having high moisture content, high dissolved salt concentrations, and high acidity are usually the most corrosive.
- e) Soil-to-air interface areas are often much more susceptible to corrosion than the rest of the structure because of moisture and oxygen availability. (Figure 3-57-1)

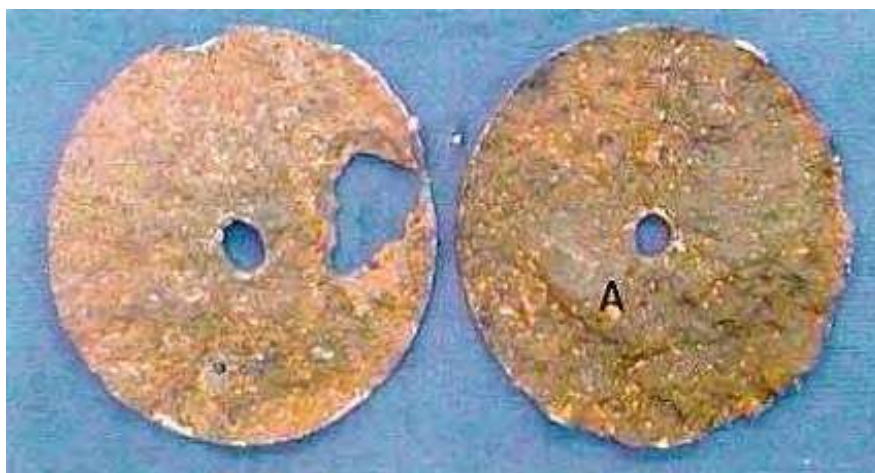
**Figure 3-57-2—Coupons removed from the bottom of an unprotected steel condensate storage tank after 3 years of service. The external surface is shown.**

- a) Underground piping and equipment as well as buried tanks and the bottoms of aboveground storage tanks. (Figure 3-57-2)
- b) Ground supported metal structures. (Figure 3-57-2)
- c) Piping running close to the ground under which soil has accumulated over the years to the point of reaching and contacting or partially covering the pipe.
- d) Piping exiting road or other crossings where soil has sloughed off and is laying on or covering the pipe.

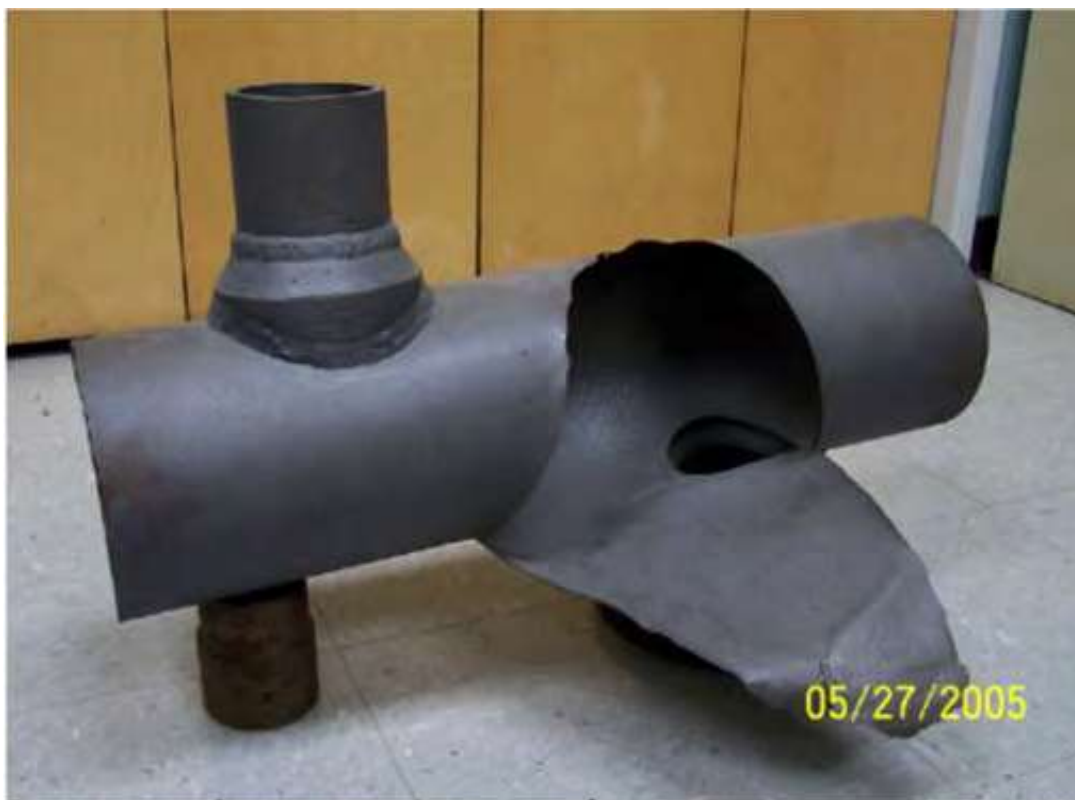
Figure 3-61-3—Sulfidation failure of an 8-in. carbon steel pipe. Note the relatively uniform thinning that resulted in a sizeable rupture.

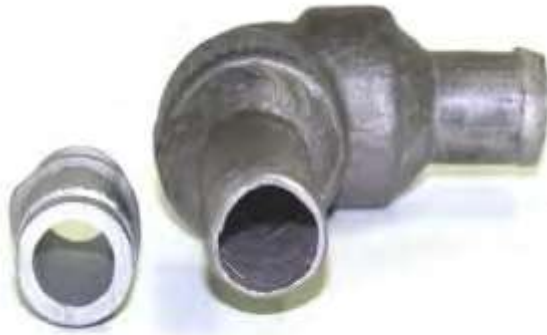
**Figure 3-61-6—Sulfidation failure of a carbon steel sight glass nipple on the right after 2 years in a crude unit. Original thickness is shown on left for comparison. Material was supposed to be 9Cr-1Mo.**

- a) Depending on service conditions, corrosion is most often in the form of uniform thinning but can also occur as localized corrosion or high-velocity erosion-corrosion damage. (Figure 3-61-3 to Figure 3-61-7)
- b) While generally having a uniform thinning morphology, the amount of thinning can vary at different locations in the system or at different locations along the length of a piping run.
  - 1. The difference in the degree of thinning between low-Si (<0.10 % Si) pipe and higher-Si ( $\geq 0.10$  Si) pipe in the same system can be large, with a marked step change in remaining wall thickness at the transition. See Figure 3-61-4 and Figure 3-61-5.
- c) A sulfide scale will usually cover the surface of components. Deposits may be thick or thin depending on the alloy, corrosiveness of the stream, and fluid flow regime and velocity.

- e) Temperatures can be monitored using tube-skin thermocouples and/or infrared thermography.
- f) Proactive and retroactive MVPs (materials verification programs) can be used for alloy verification and to check for alloy mix-ups in services where sulfidation is anticipated. (API 578 provides guidance on MVPs.) See [Figure 3-61-6](#).

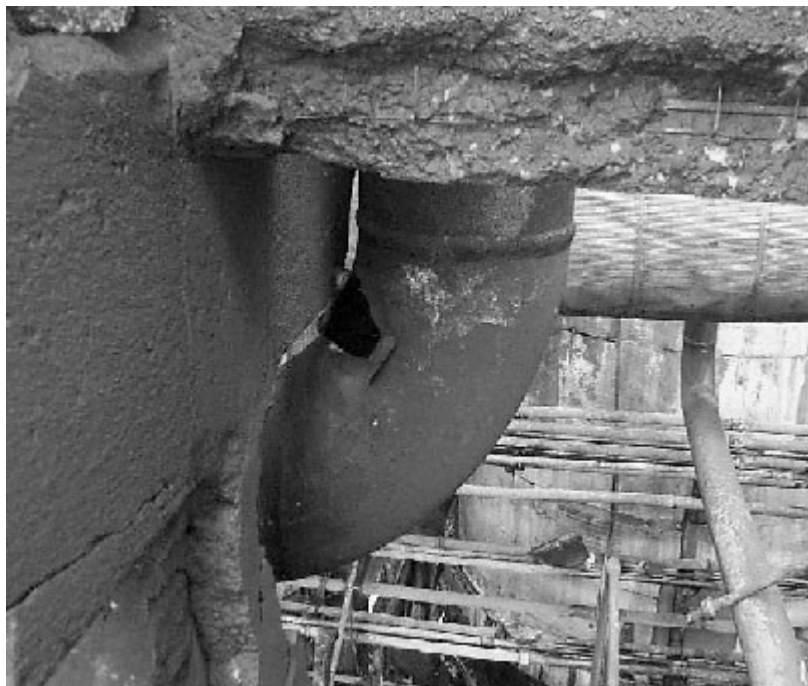
**Figure 3-61-7—Sulfidation failure of piping elbow.**

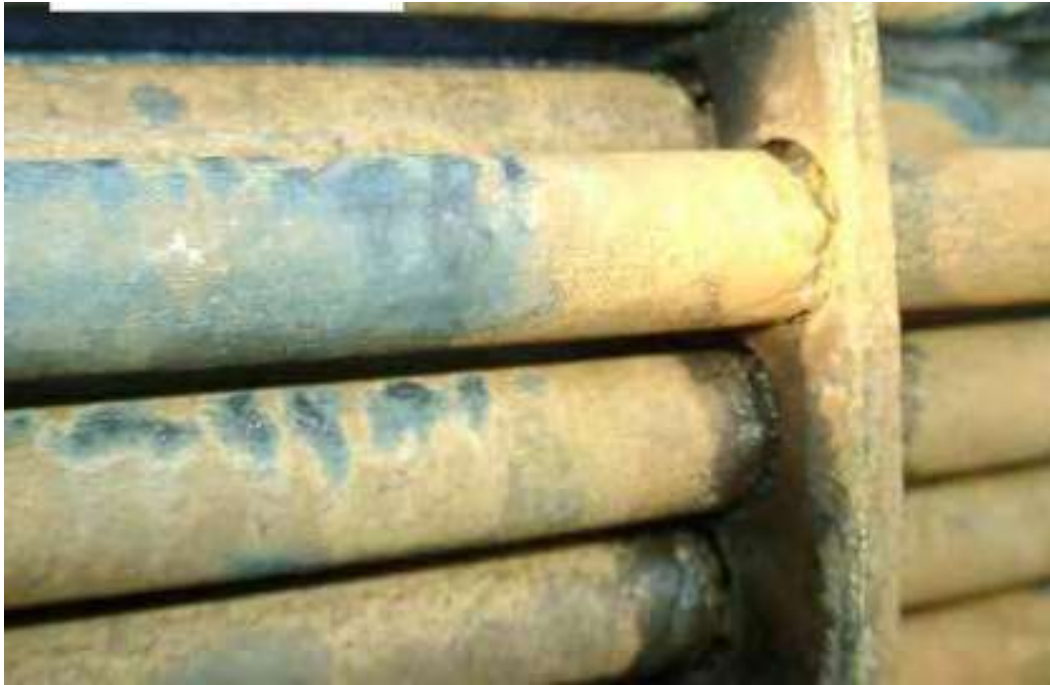
**Figure 3-62-2—Accelerated sulfuric acid corrosion under a baffle.**

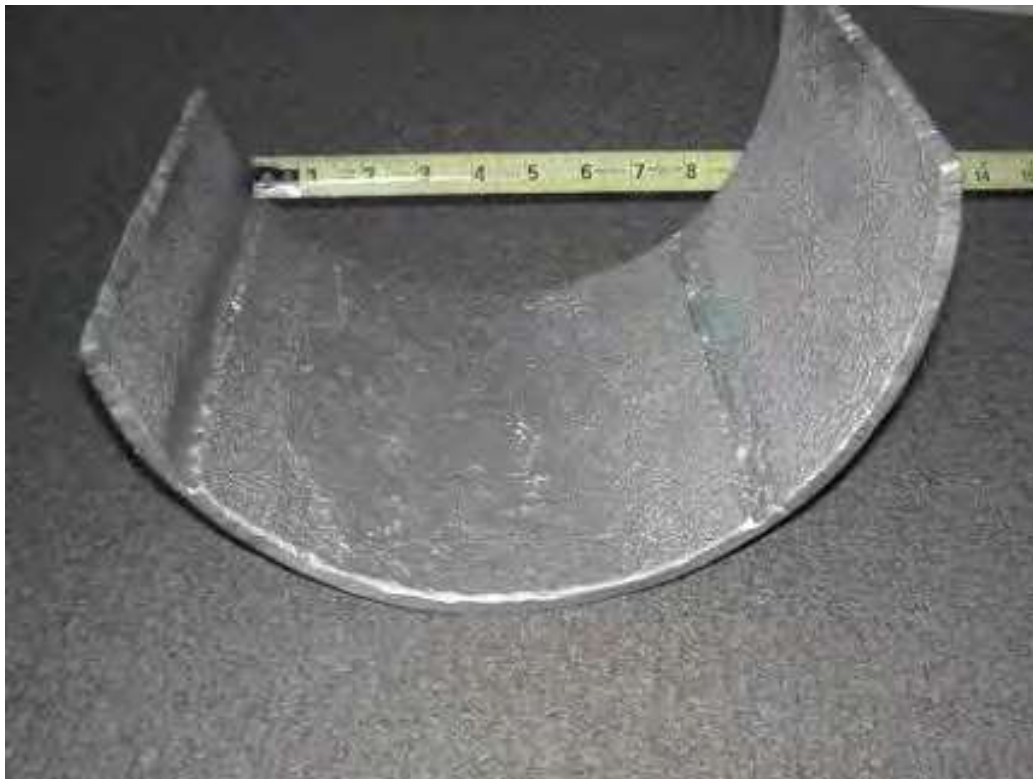
**Figure 3-62-3—Grooving corrosion in the carbon steel vapor line from an alkaline water wash drum in a sulfuric acid alkylation unit.**

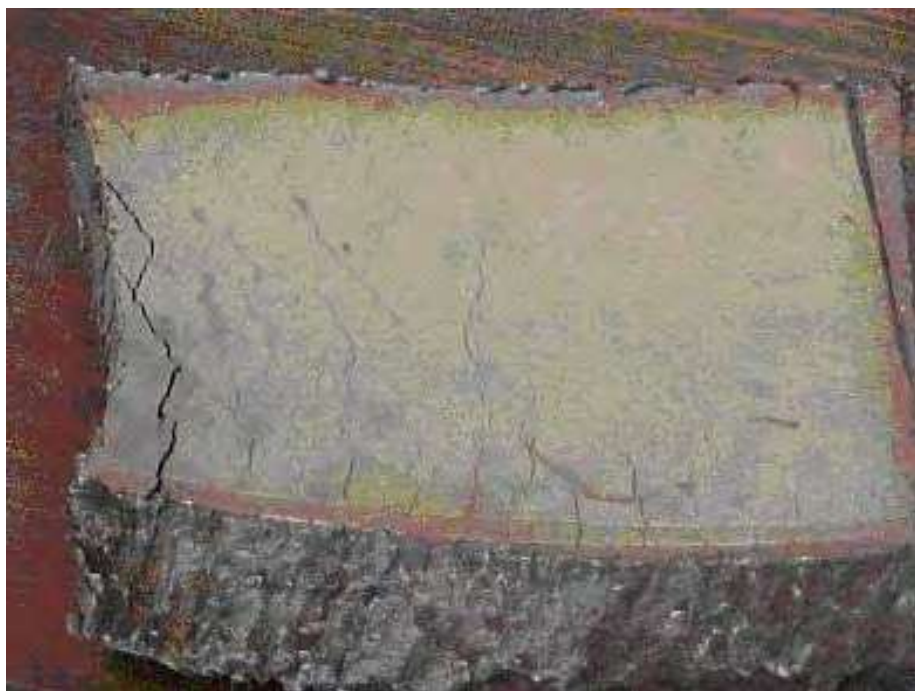
**Figure 3-64-1—Thermal fatigue cracks on the inside of a heavy wall SS pipe downstream of cooler H<sub>2</sub> injection into a hot hydrocarbon line.**

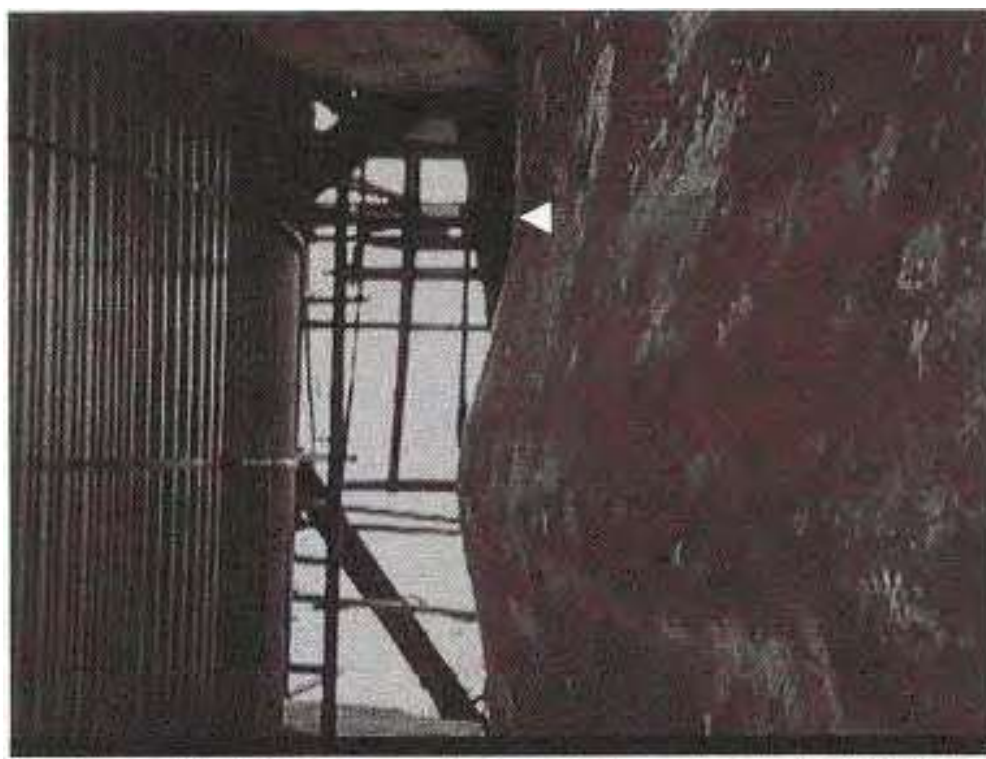
**Figure 3-64-3—Bulging in a skirt of a coke drum due to thermal cycling from coker operation.**

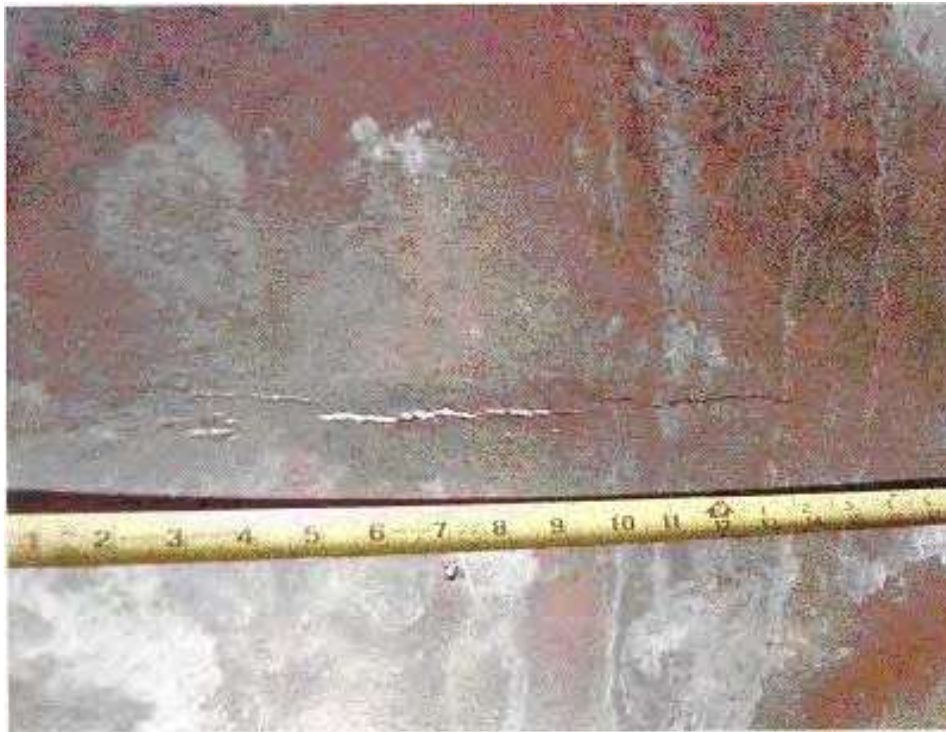
**Figure 3-64-4—Thermal fatigue cracking associated with bulged skirt shown in Figure 3-64-3.**

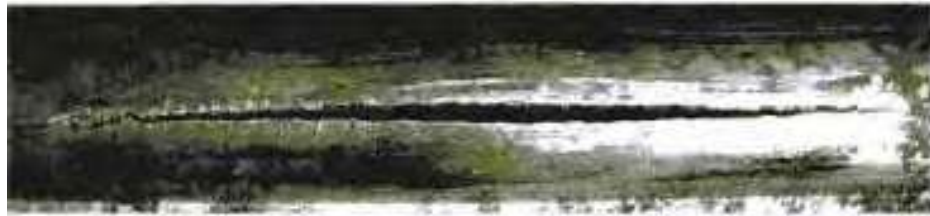
**Figure 3-66-1—Titanium heat exchanger tube that failed from hydriding in a SW cooler. The cooling medium was seawater.**

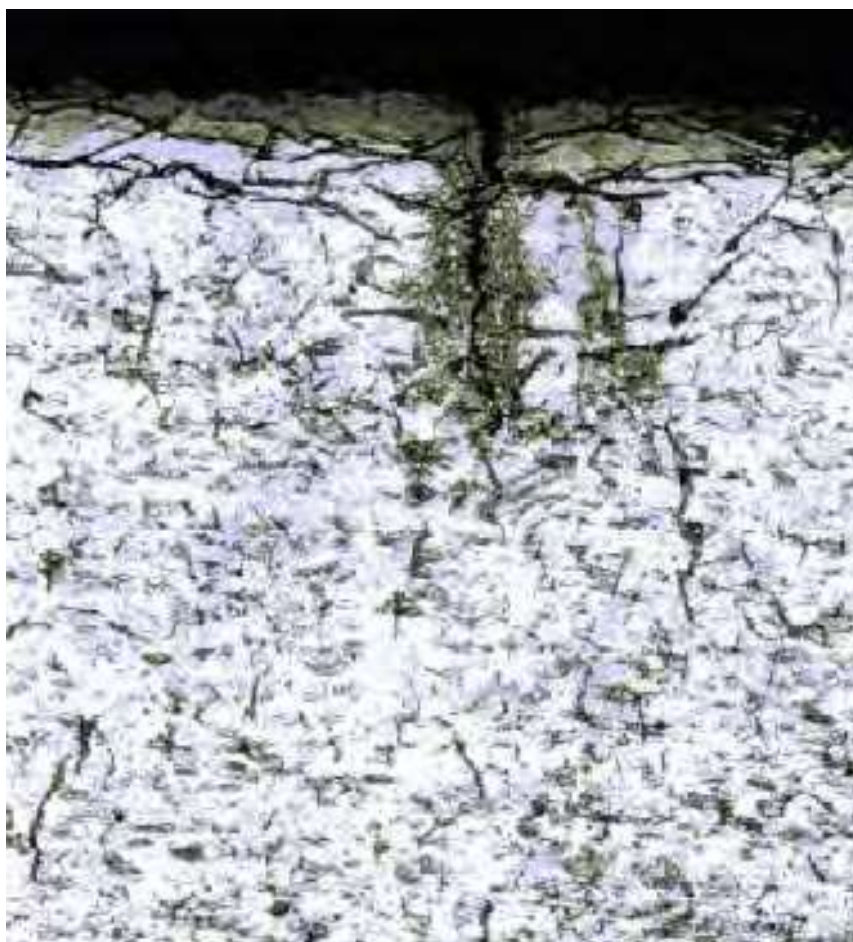
**Figure 3-66-2—High-magnification photomicrograph of a cross section of the tube shown in Figure 3-66-1 through the crack tip. Magnification 200X.**

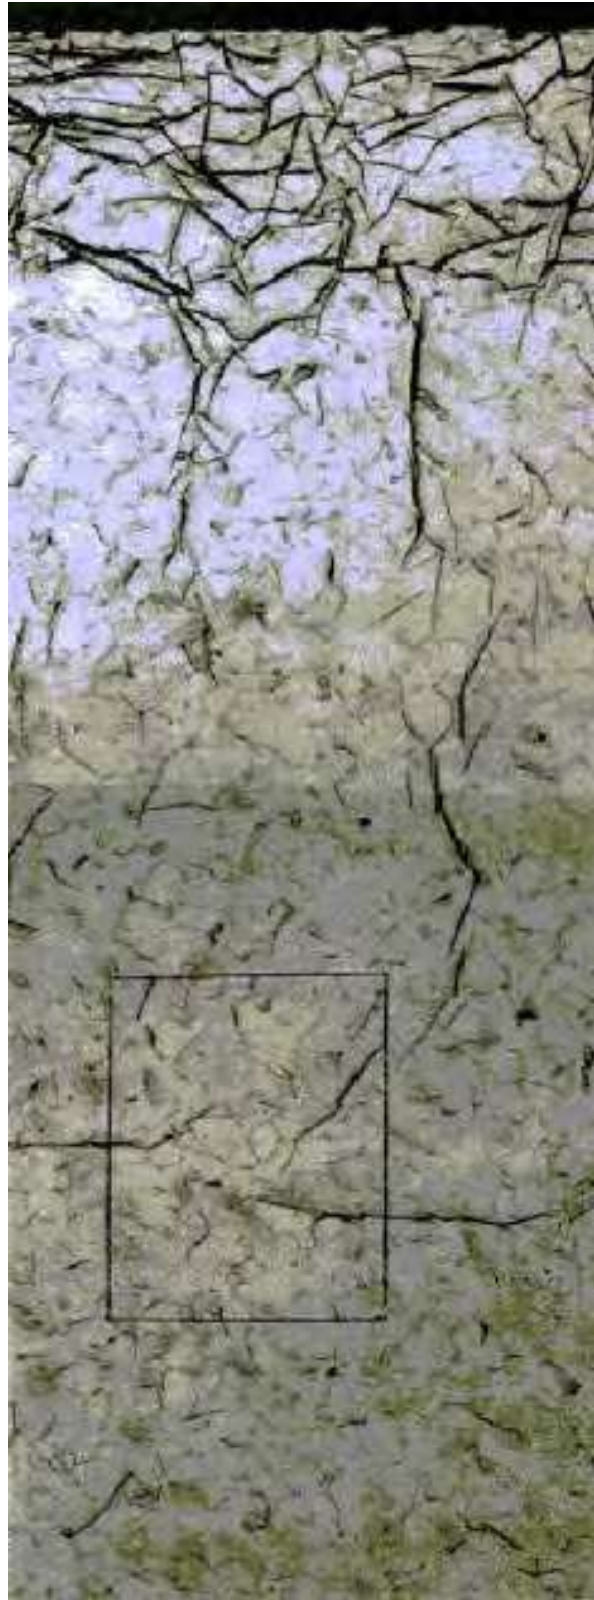
**Figure 3-66-3—Another high-magnification photomicrograph of a cross section of the tube in Figure 3-66-1, showing more of the cross section through the tip of the crack. Titanium hydrides are more clearly discernable. Magnification 400X.**

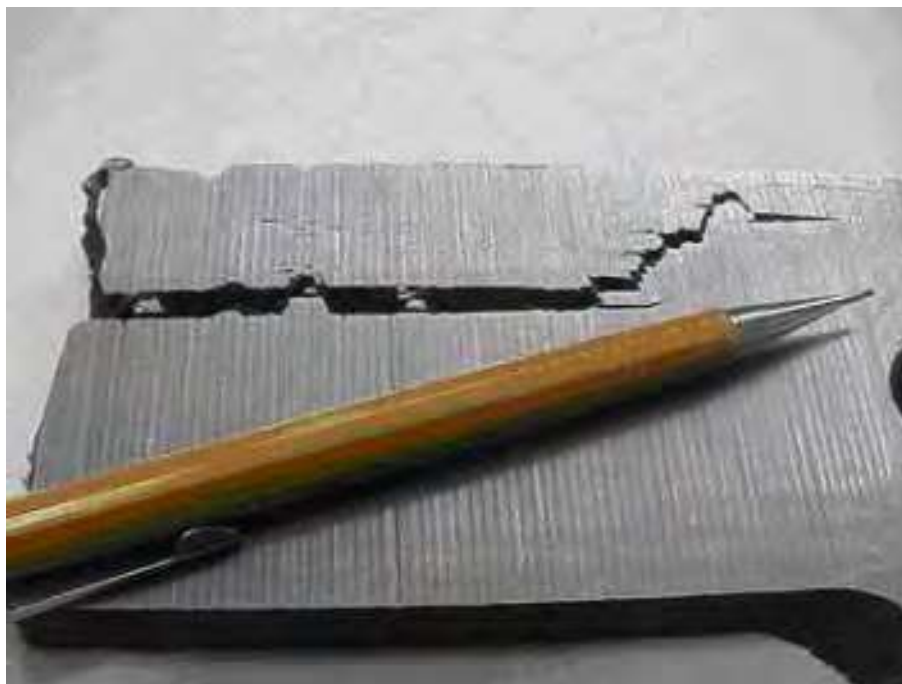
**Figure 3-67-3—HIC damage as shown in the cross section of the shell of a trim cooler that had been cooling vapors off a hot high-pressure separator (HHPS) vessel in a hydroprocessing unit.**

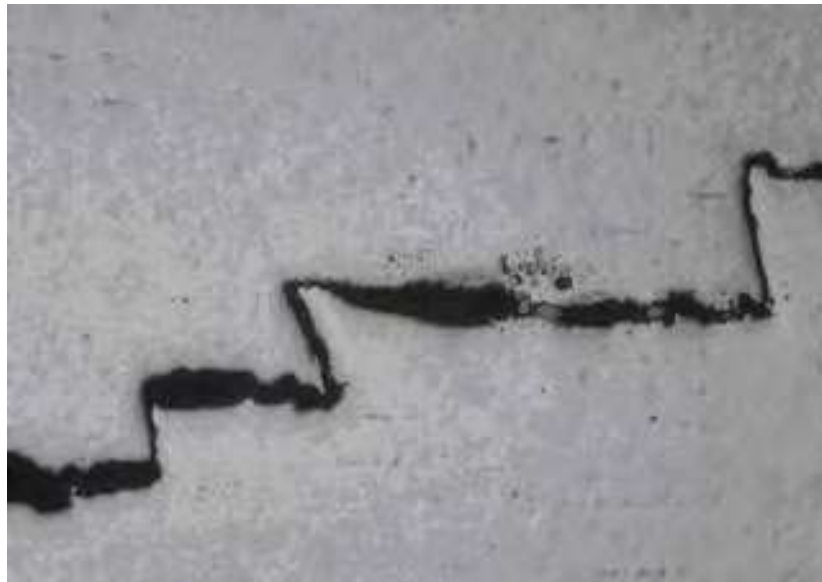
**Figure 3-67-5—High-magnification photomicrograph showing stepwise cracking nature of HIC damage.**

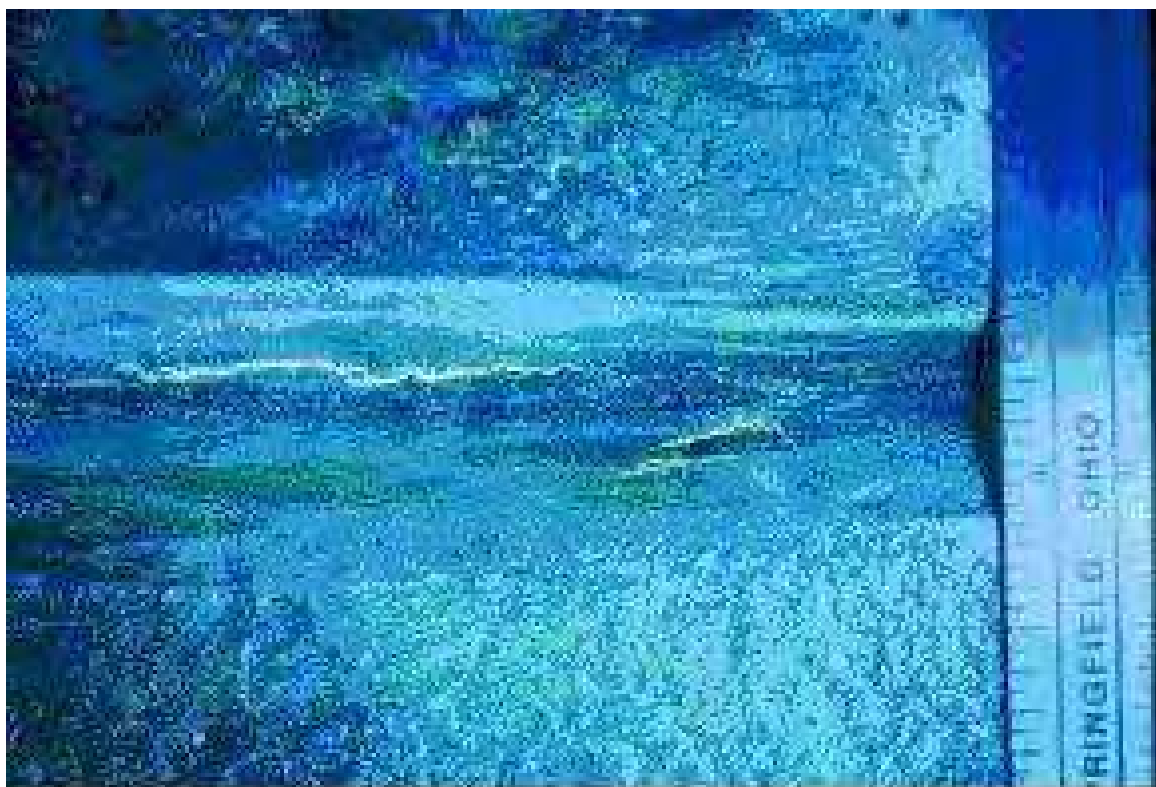
**Figure3-67-8—Photograph showing WFMT indication of SOHIC damage.**
